TECHNICAL REPORT N-70-10

**SURVEY OF GULF COAST
STRUCTURAL DAMAGE RESULTING FROM
HURRICANE CAMILLE, AUGUST 1969**

By U. S. Army Engineer Waterways Experiment Station, Vicksburg, Mississippi

April 1970

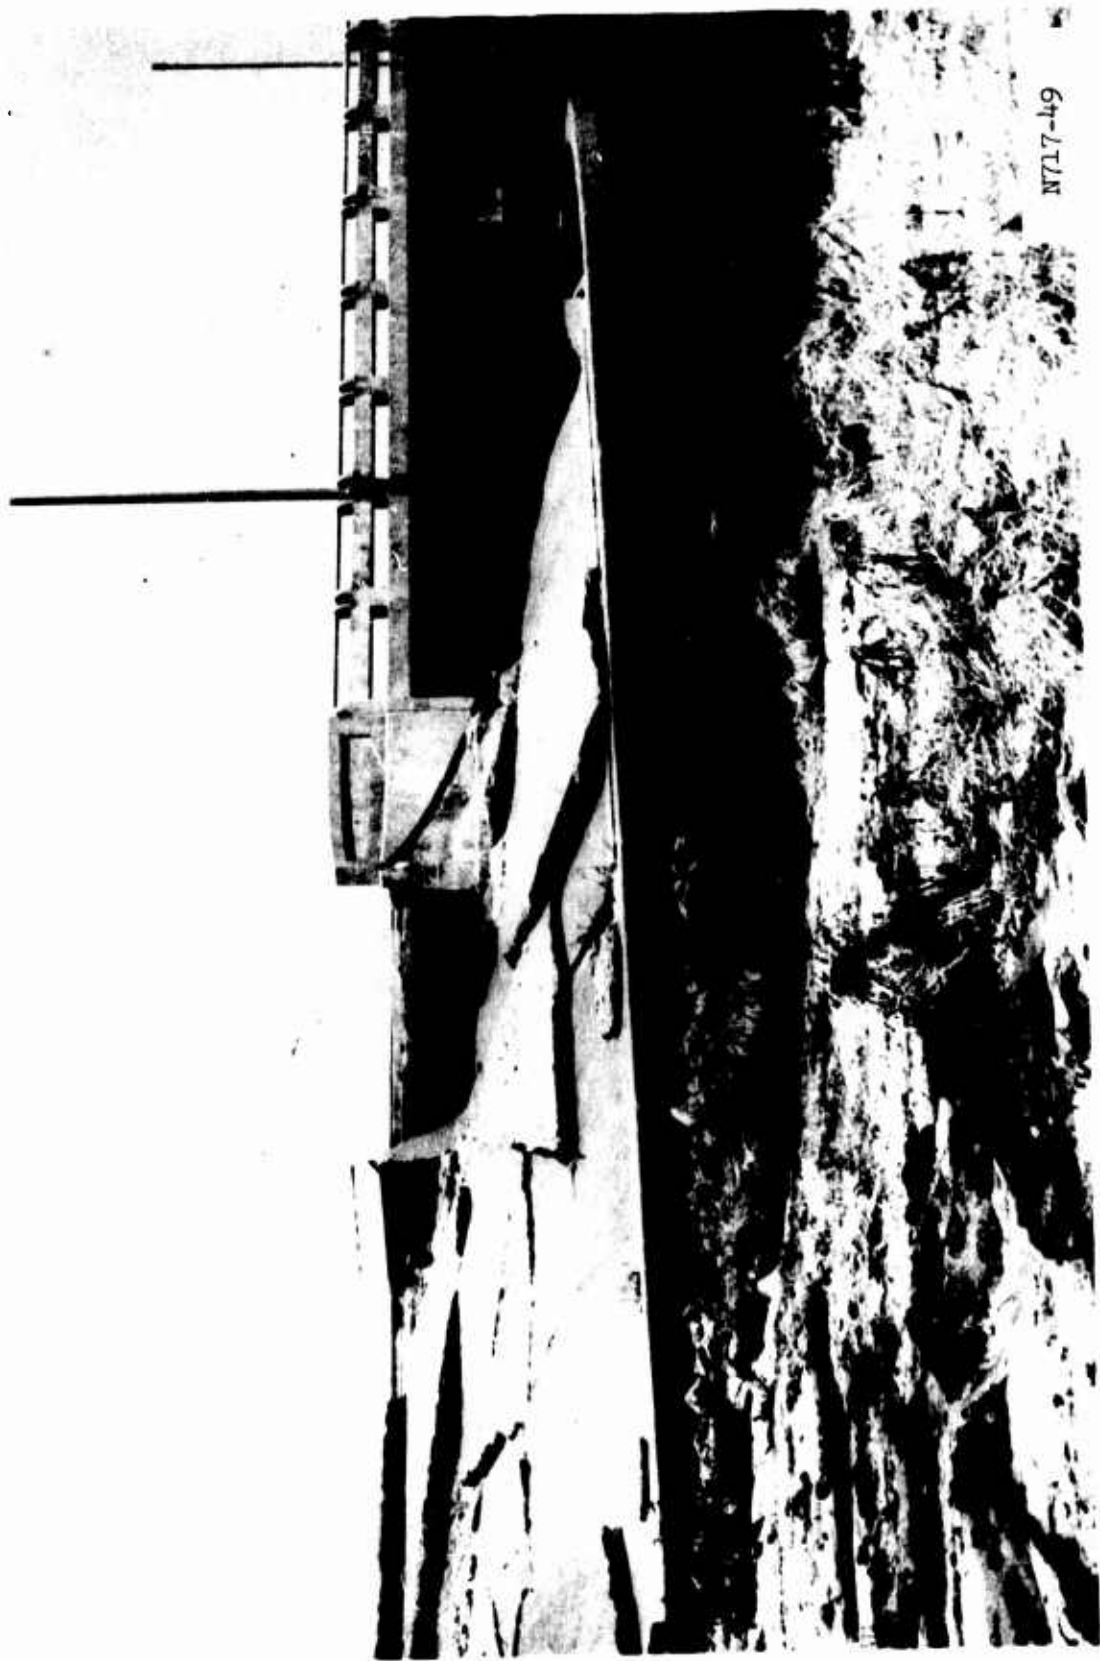
N717-49

The water appeared to have lifted the seaward deck slabs up enough for the rocker bearings on the east end of each span to fall out, resulting in a sawtooth appearance along the south side of the bridge (Figures 3.52 and 3.53). Some of the railing sections were tilted inland, and all but one lamp was torn from its pole. One span was moved about 4 feet laterally (Figure 3.54). Considerable concrete was spalled along the bridge centerline where the two deck slabs joined. The west abutment was heavily damaged by wave action (Figure 3.55).

Figure 3.55 West abutment of Bay Saint Louis Bridge.
